**PRELIMINARY ASSESSMENT/
VISUAL SITE INSPECTION**

**ACE IRON AND METALS, INC.
(Formerly Process Alliance Partnership)
JOLIET, ILLINOIS
ILD 006 665 752**

FINAL REPORT

**U.S. ENVIRONMENTAL PROTECTION AGENCY
Office of Waste Programs Enforcement
Washington, DC 20460**

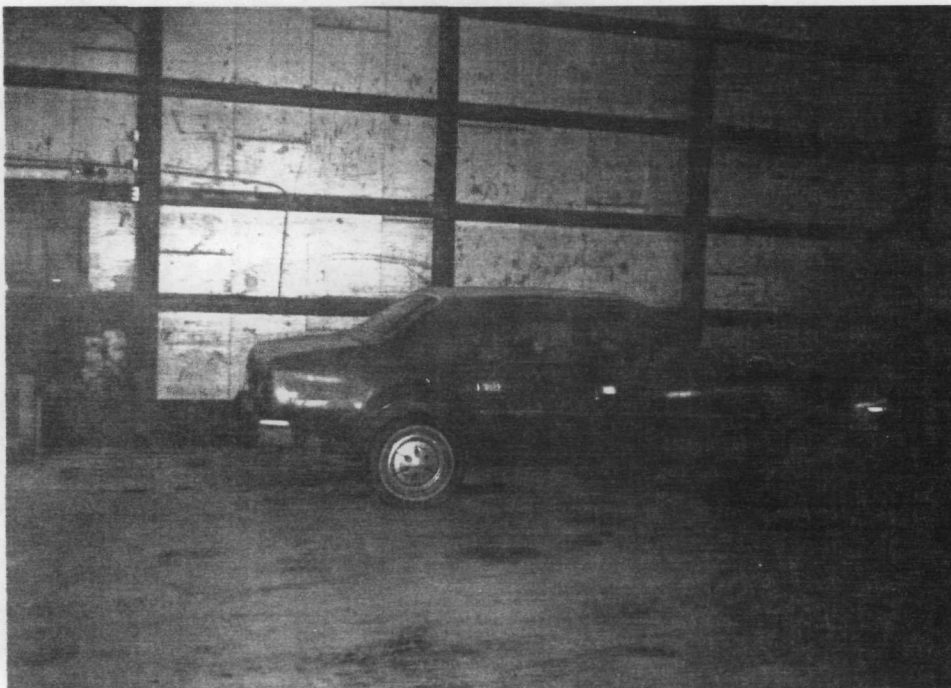
Photograph No. 2

Description: North wall of facility building; area of former Waste Treatment Unit

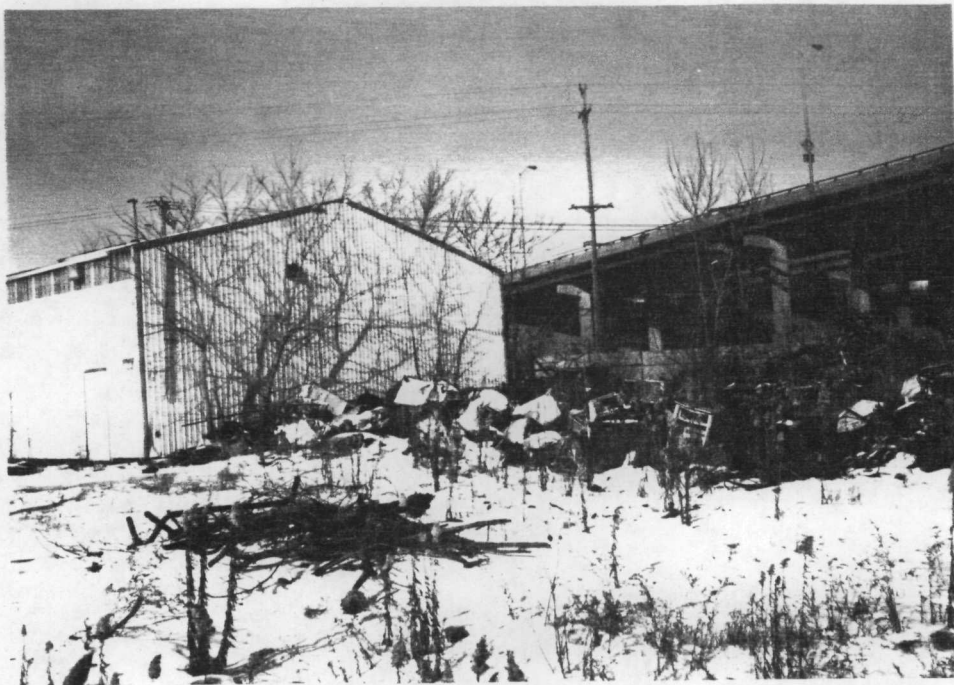
Photograph No. 5

The storage tanks are no longer present at the facility. The area is currently used to store scrap metal. During the VSI, the ground around the SWMU's former location was covered with snow. PRC noted no evidence of release (see Photographs No. 5, 6, and 7).

Description: Outdoors and east of facility building; area of former Waste Storage Areas; currently used for scrap metal storage

Recommendations: PRC recommends that Ace submit all documentation regarding soil samples taken in this area in June 1983 to determine if contamination exists.

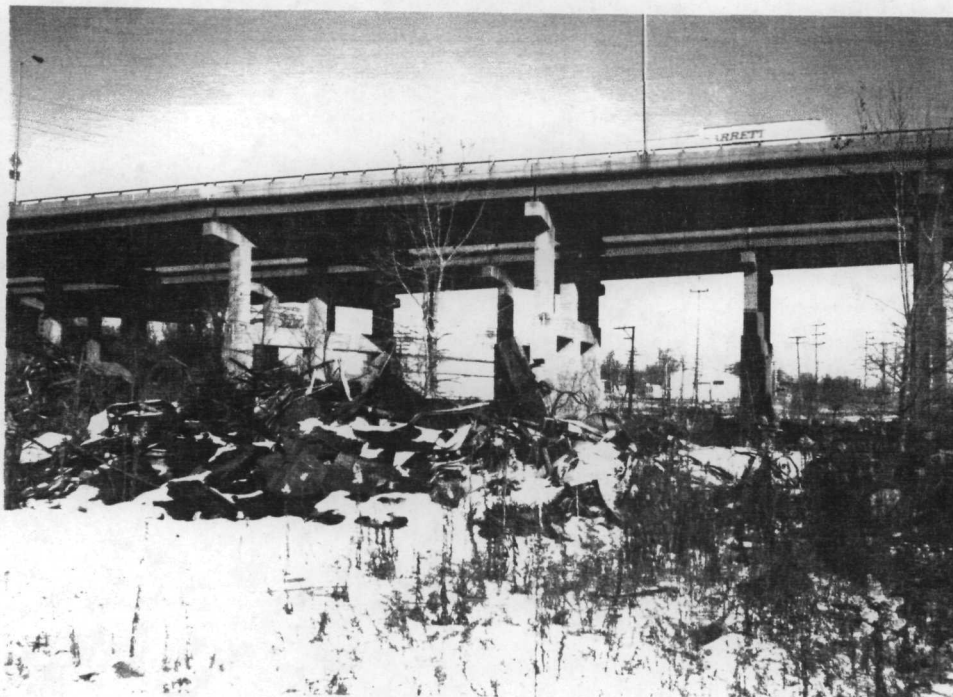
Photograph No. 6

Description: Outdoors and east of facility building; area of former Waste Storage Areas; currently used for scrap metal storage
